Drawing Title **Scope of Work, South and West Elevations**
 Project **Repairing our Lady Star of the Sea and Opening Doors, Lowestoft.**
 Client **Parish Finance Committee**
 Drawn: **GH - 22/12/2017**

Job No Dwg No
654 /3201
 Scale
1:200 @A3
 Rev
 Date

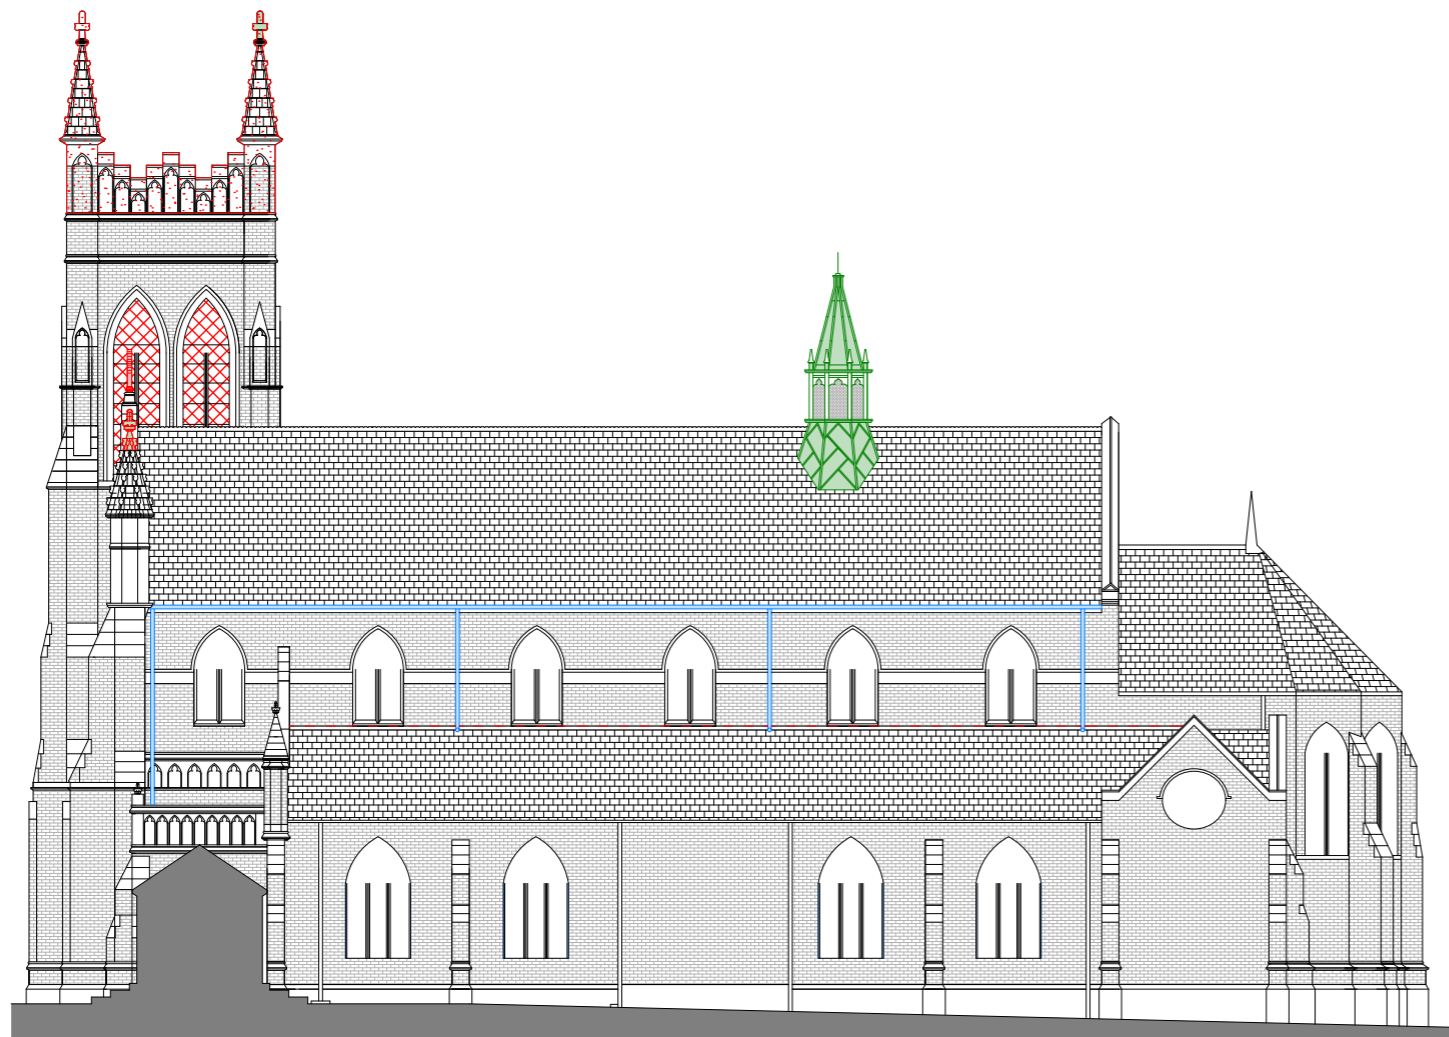
Scope of Work, South Elevation, 1:200

- Stone replacement
- Terracotta replacement
- Rake out joints and repoint with lime mortar
- Replace bird mesh and repair mullions in the Belfry Openings
- New/replacement rainwater goods
- Repair and redecorate existing rainwater goods/ vent pipes
- Repoint failed mortar joints above flashing at North & South Aisle abutments to Clerestories
- Replace apex cross on West Porch and west end of Nave
- Repair timber structure and replace copper covering on the Nave Flèche
